WINNEBAGO COUNTY WATERSHED IMPROVEMENT PLAN: MADIGAN CREEK WATERSHED

EXECUTIVE SUMMARY JULY 2013

Hey and Associates, Inc.

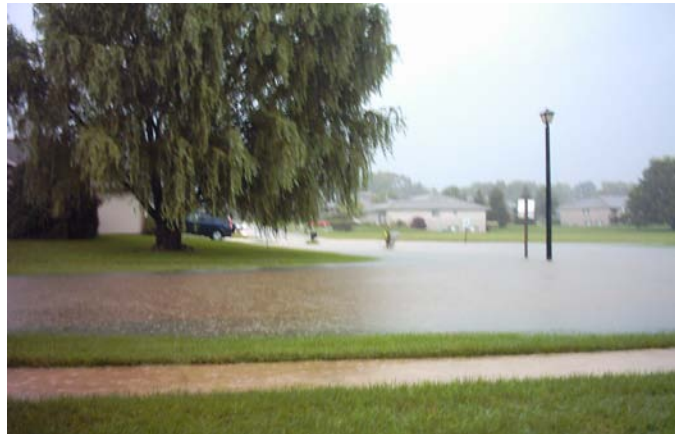
Figure 4: Localized Flooding

Figures 4, 5, and 6 below includes photos of problem areas identified in the watershed. Goals were drafted directly from the concerns expressed by the stakeholders. The final goals were adopted on November 2, 2011 and capture the desired outcomes and vision for the Madigan Creek watershed. Objectives assigned to each goal are intended to be measurable so that the WCWIPSC can assess future progress made towards each goal.

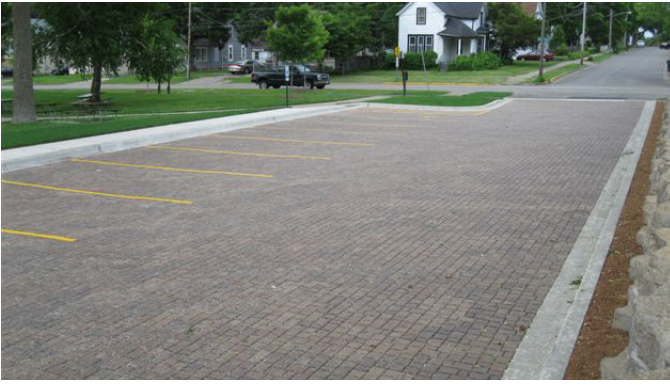
Figure 7: Permeable Paver Parking Lot

- Reduce impervious areas by incorporating permeable pavements and bioinfiltration practices such as depressed islands and rain gardens in parking lots and streets throughout the watershed.

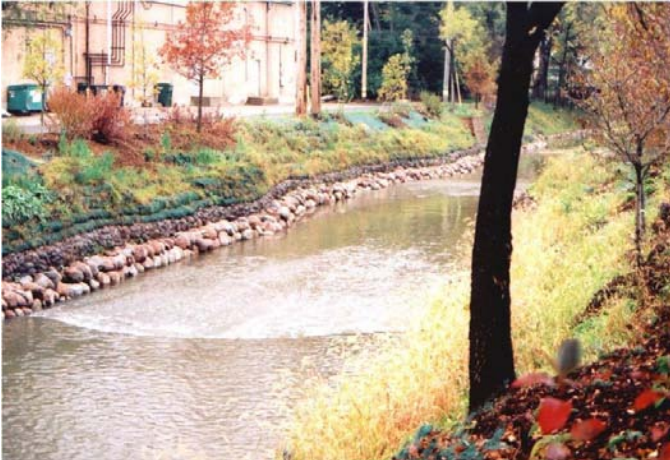
Figure 7: Stream Riffles/Slope Stabilization

- Stabilize streambanks to reduce erosion, protect property and infrastructure, and improve water quality and habitat.
- Remove the concrete channel and replace with a more naturalized channel using bioengineering techniques in order to improve water quality and habitat.

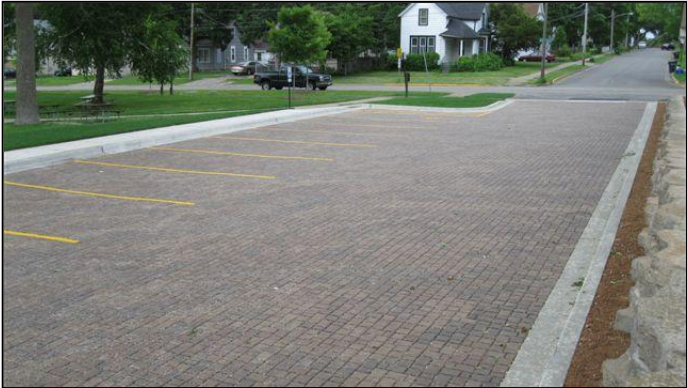
Permeable Pavement

Permeable pavement removes suspended solids through filtration. Dissolved pollutants such as nutrients and metals are removed and/or transformed as runoff infiltrates into the soil. Utilizing the Illinois EPA’s Estimating Pollutant Load Reductions for Nonpoint Source Pollution Control BMPs worksheets, the permeable pavement can remove approximately 65% of the total phosphorous, 85% of total nitrogen, and 90% of total suspended solids.

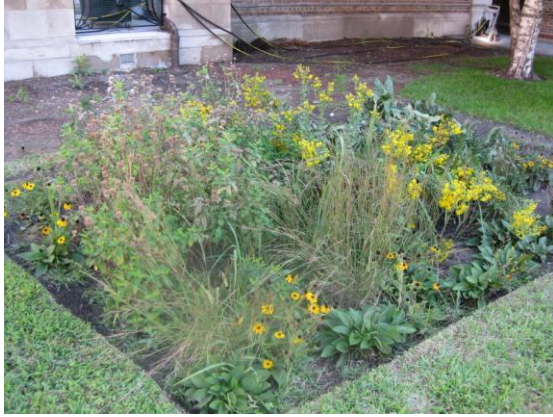
How Do Rain Gardens Help Manage Stormwater?

Rain gardens are one of the many BMPs that you can implement at home to reduce the impacts of stormwater in your watershed. Building a rain garden is one of the simplest, easiest and most cost effective ways you can protect water quality at home. The purpose of a rain garden at home is to store and promote the infiltration of rainfall into the groundwater. Without the rain garden, the majority of the rain that falls onto the impervious surfaces around your home such as driveways, sidewalks, and roofs will flow directly into the sewer system or nearby lakes or streams. When properly constructed

a rain garden will reduce the amount of runoff from your property. In addition, the plants in the rain garden will also reduce the amount of pollutants in stormwater runoff. Suspended sediments and attached pollutants such as phosphorus and metals are settled out of the stormwater and captured in the basin. Dissolved pollutants such as nitrogen and organic matter are filtered out and/or transformed by the vegetation and as the runoff infiltrates into the underlying soils.
